Project Report

Structural Investigations Hotel del Sol Yuma, Arizona

Prepared by:
Atkinson-Noland & Associates, Inc.
2619 Spruce Street
Boulder, CO 80302
303-444-3620

December 23, 2007

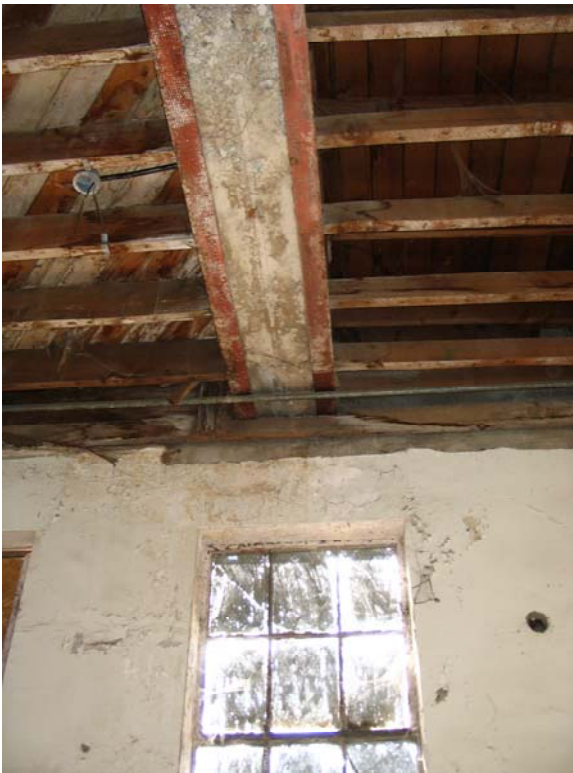
Figure 1. Concrete beam at Gridline 4 at south exterior wall. This beam supports the concrete walls on the second and third floors. Note bearing location above window head at exterior concrete wall.

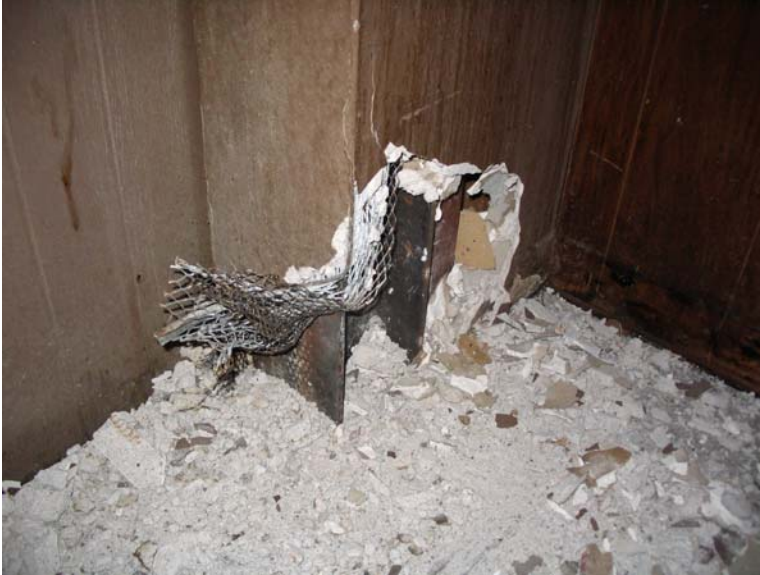
Figure 2. Plaster and lathe removed from column base to expose steel cross section for measurements.

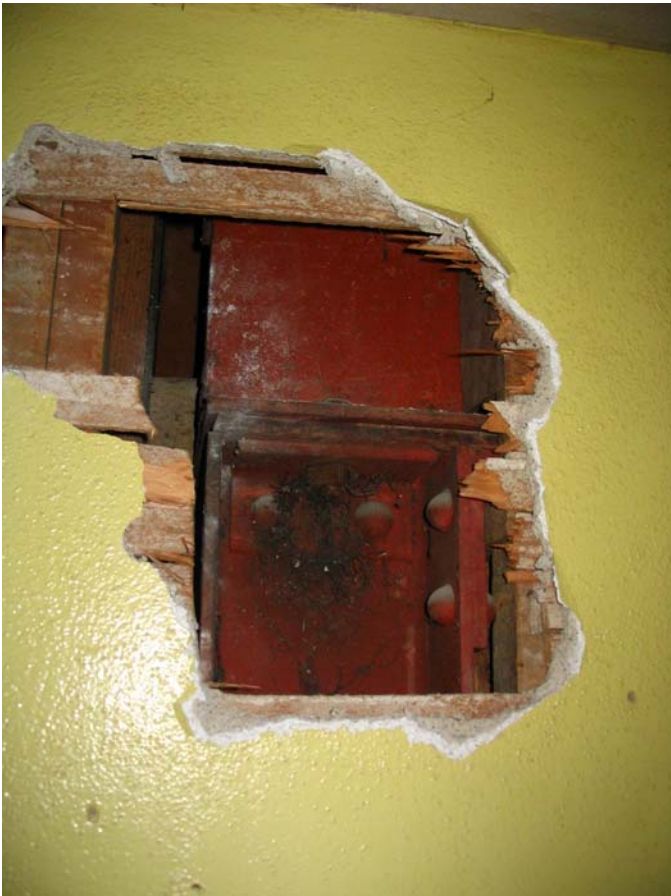
Figure 3. Top of column and end of beam visible in opening. Most connections are riveted, however bolted connections were also observed.

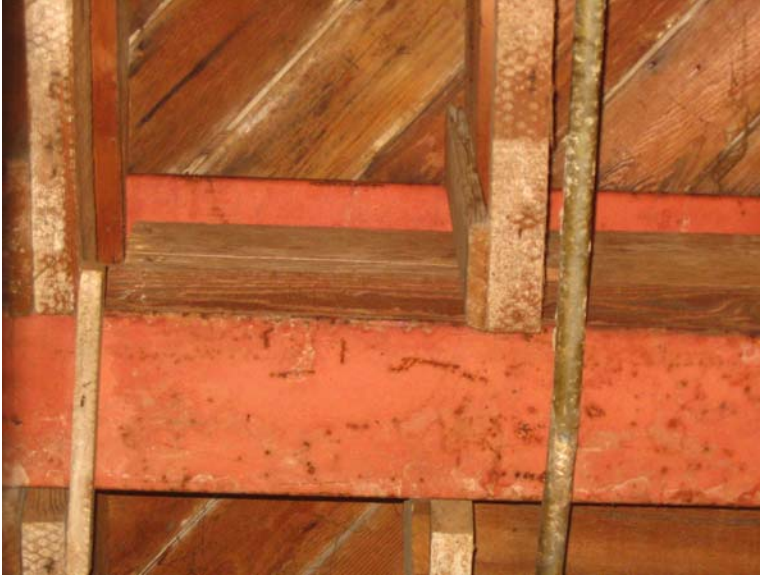
Figure 4. View from below of typical beam supporting second floor wood framing.

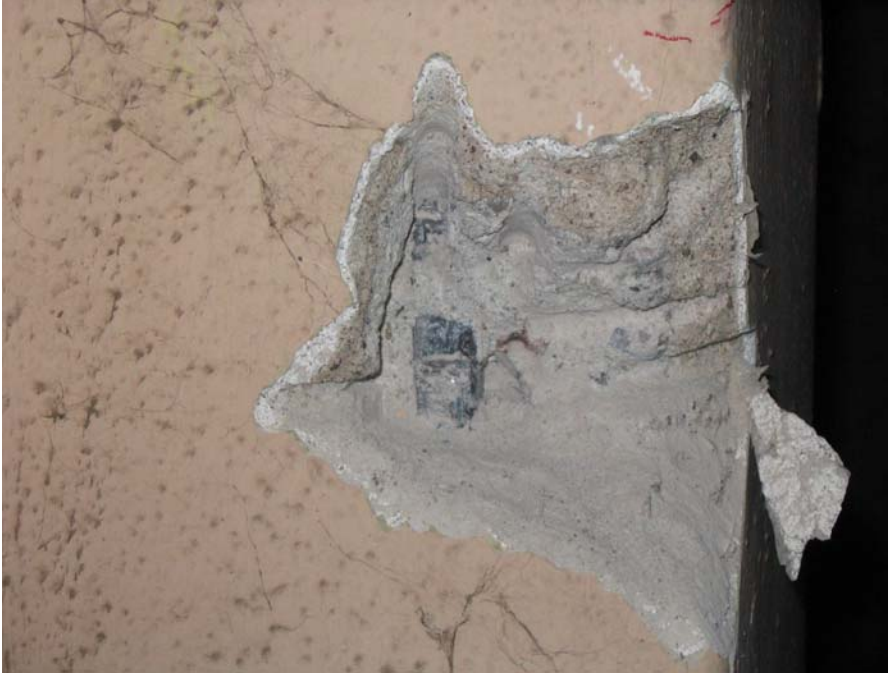
The thickened wall sections at column lines were investigated and found to contain a reinforcing bar at each corner of the cross section. A probe at one column indicated the column is reinforced with four $\frac{3}{4}$ inch square, deformed bars. Figure 5 shows the location and condition of the exposed bar.

Figure 5. Exposed reinforcing bar in corner of concrete column

Various spalls, cracks, delaminations, and cold joints are evident on the exterior of the Hotel del Sol. These should be addressed during the renovation of the hotel. Proper preparation of the substrate and patching with compatible cementitious materials will reduce moisture infiltration and protect the reinforcing steel.

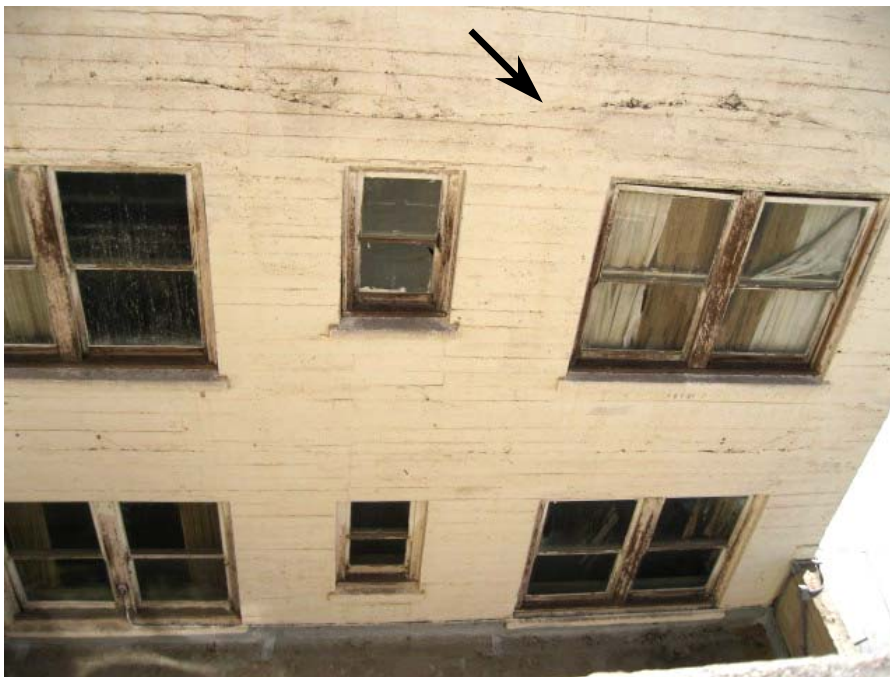
Figure 6. Typical cold joint (west elevation of west light well) as found on most elevations. The interface between successive concrete pours is not well consolidated.
