Project Report

Structural Investigations Hotel del Sol Yuma, Arizona

Prepared by:
Atkinson-Noland & Associates, Inc.
2619 Spruce Street
Boulder, CO 80302
303-444-3620

December 23, 2007

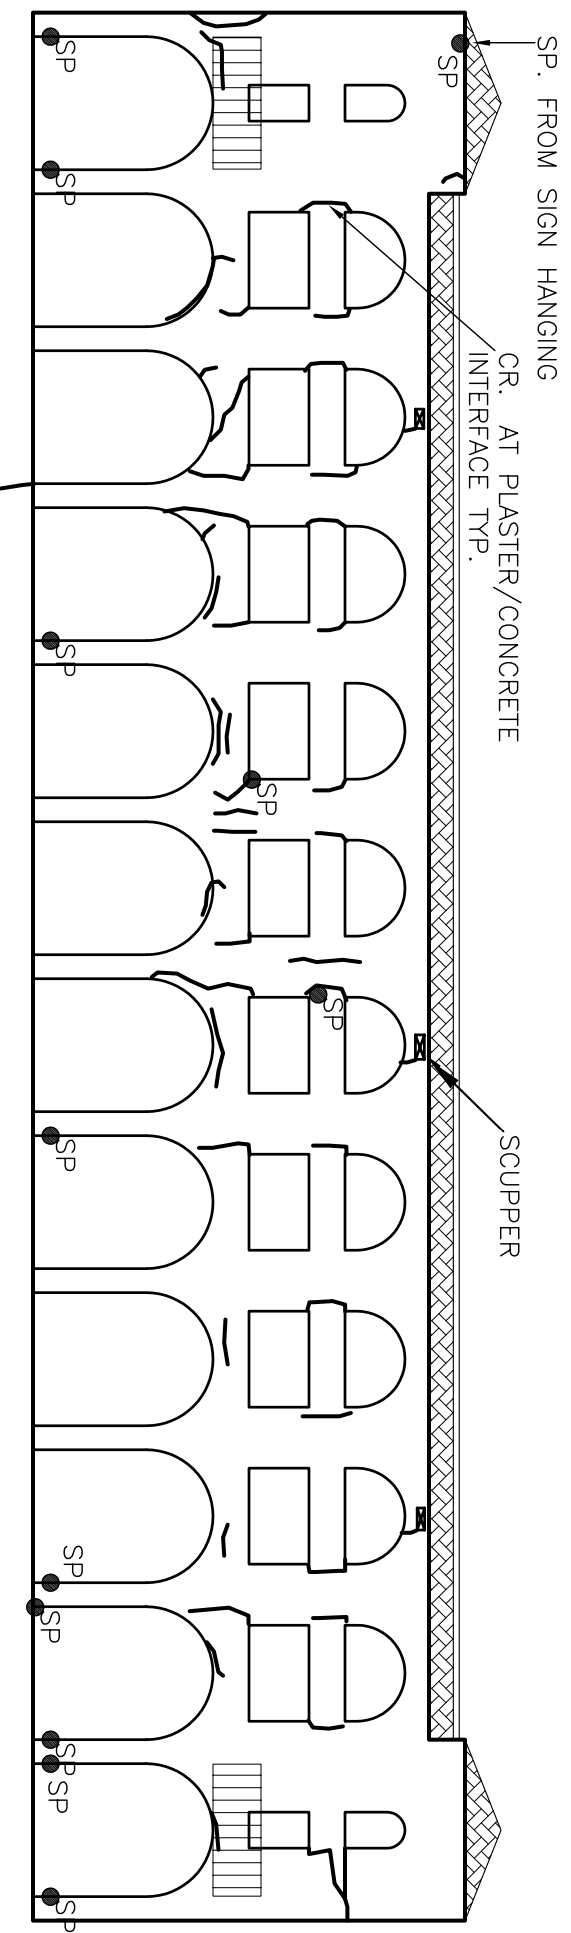
1 North Elevation
Scale: 1/16" = 1'-0"

A condition survey of the exterior walls of the Hotel del Sol was conducted from ground level, the sleeping porches, and the roof using visual methods. All cracks, spalls, delaminated plaster, and cold joints between concrete pours were noted on elevation drawings. The condition survey drawings are contained in Appendix A. In general, the building is good condition for the age of the structure.

Various spalls, cracks, delaminations, and cold joints are evident on the exterior of the Hotel del Sol. These should be addressed during the renovation of the hotel. Proper preparation of the substrate and patching with compatible cementitious materials will reduce moisture infiltration and protect the reinforcing steel.
